Preliminary Subsoil and Geologic Hazard Evaluation
Mountain Meadow Preserve
Blocks 2 & 3, Sky Harbor Subdivision, Steamboat Springs, Colorado

Job No. 99-1994

June 24, 1999

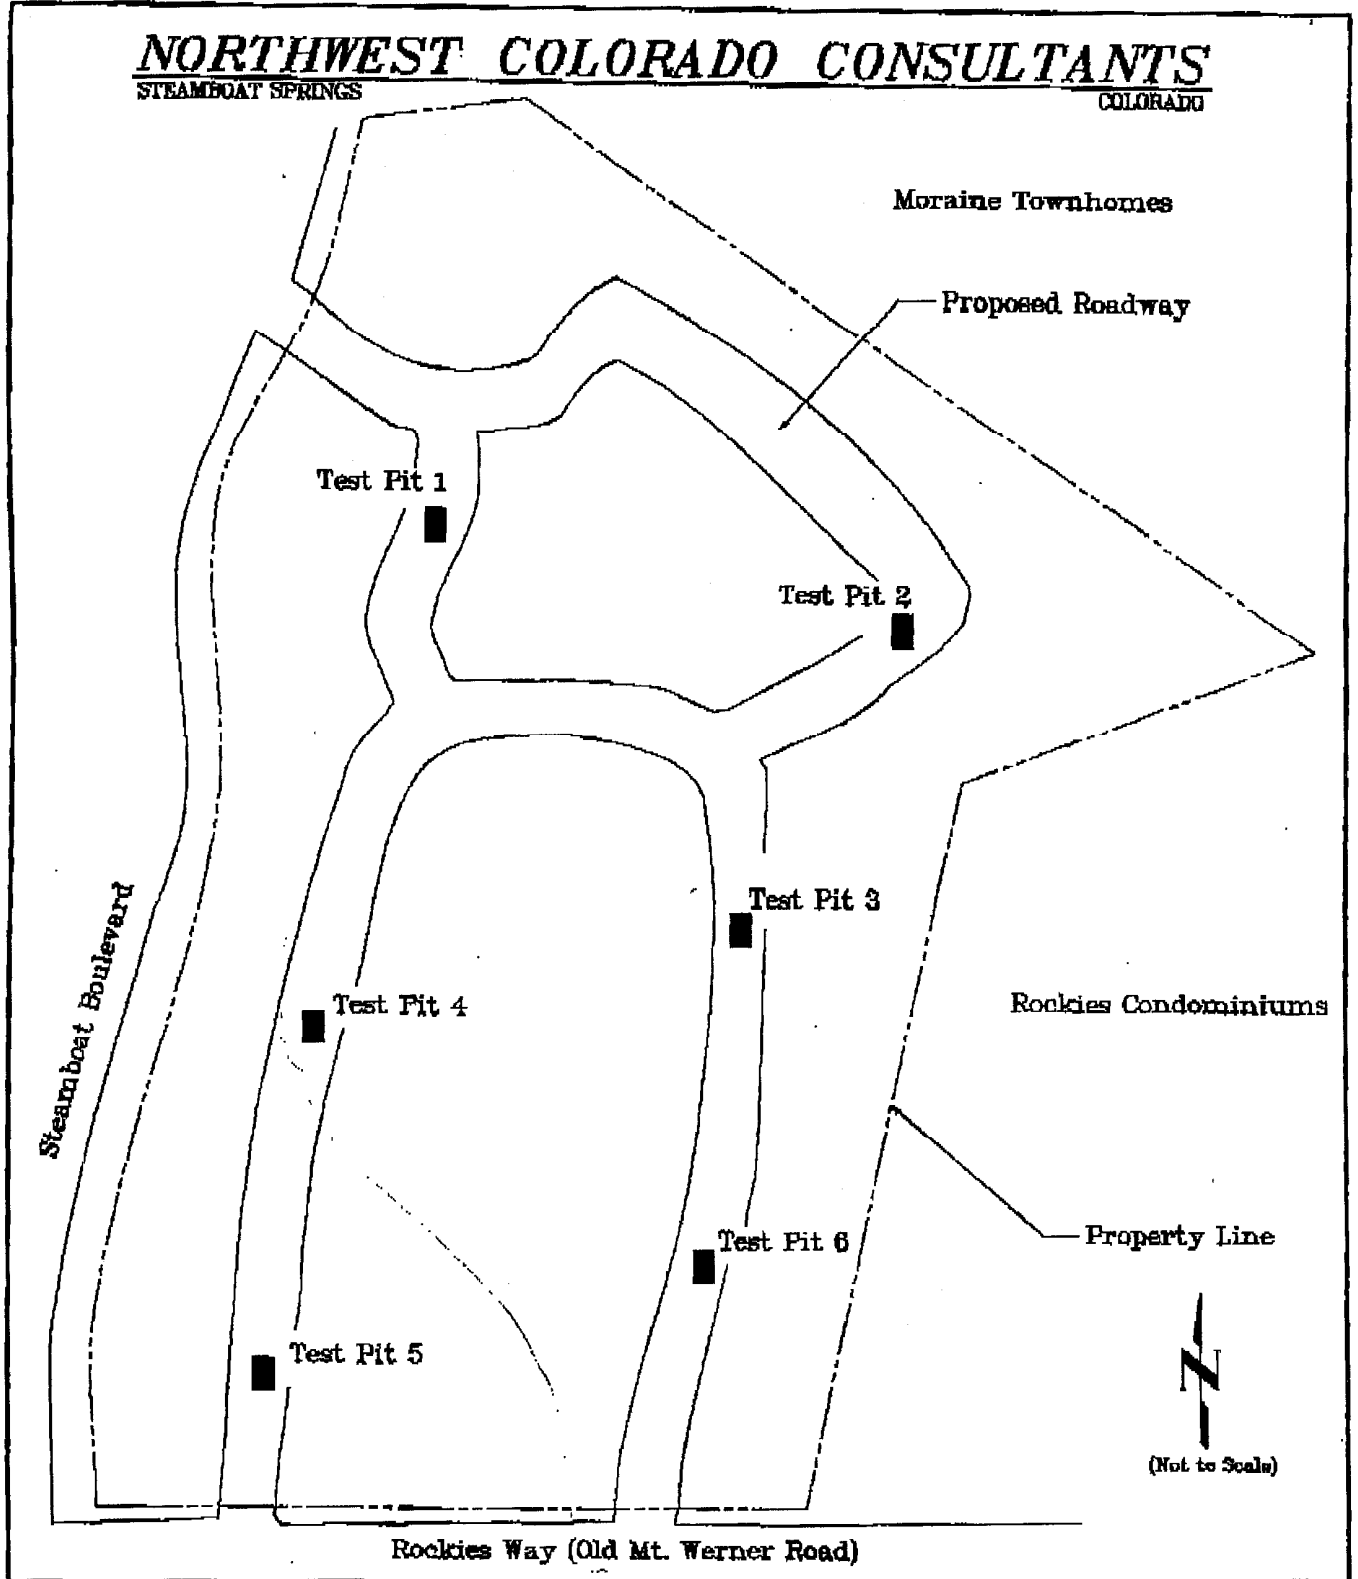
SITE PLAN / LOCATION OF TEST PITS

The field investigation for the project was conducted on June 10, 1999. Six (6) test pits were advanced at the approximate locations shown on Figure #2 to explore the subsurface conditions across the site. The locations of the test pits were determined by NWCC and the actual test pit locations were surveyed by Johnson Kunkel. It should be noted that the test pits were located at proposed sanitary sewer manhole sites. The elevations of the test pits were determined by interpolating between contours shown on the site plan provided. The test pits were advanced with a Cat 312 trackhoe and were logged by a representative of NWCC, Inc.

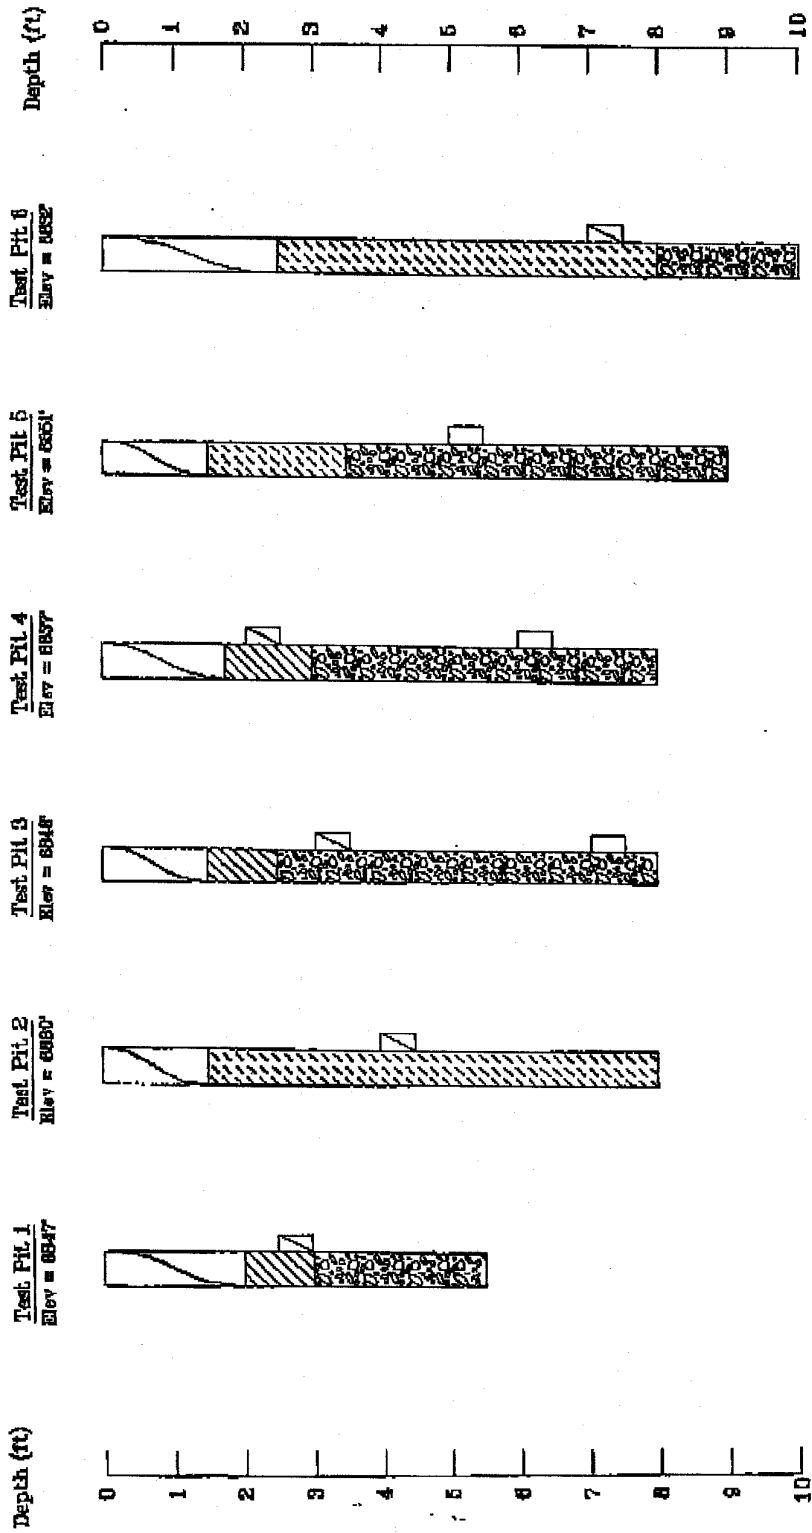
LOGS OF EXPLORATORY TEST PITS

The subsurface conditions encountered in the test pits were somewhat variable and generally consisted of a layer of topsoil overlying natural clays and silts, clays, and sands and gravels to the maximum depth investigated, 10 feet. Graphic logs of the test pits are shown in Figure #3.

Topsoil was encountered at the ground surface in all of the test pits and ranged in thickness from approximately 18 to 30 inches. The topsoil was typically silty to clayey, dry to wet and black to brown in color. A layer of natural clay and silt was encountered in test pits 1, 3 and 4 below the topsoil materials. The clay and silt layer was approximately 12 to 18 inches thick. The clay and silt materials were slightly sandy to sandy, low to moderately plastic, soft, wet and mottled brown with iron staining. Samples of the clay and silt classified as CL-ML and CL soils in accordance with the Unified Soil Classification System.

Natural clays were encountered below the topsoil in test pits 2, 5 and 6 and extended to depths ranging from 3 1/2 to 8 feet below the ground surface. The clays were sandy to slightly sandy, moderately to highly plastic, stiff to very stiff, moist and brown to reddish brown in color. The clays classified as CL soils in accordance with the Unified Soil Classification System.

Natural sands and gravels were encountered beneath the clay and silt layer in test pits 1, 3 and 4 and beneath the clay layer in test pits 5 and 6 at depths ranging from 2 1/2 to 8 feet below the ground surface. The sands and gravels were silty to very clayey, fine to coarse grained with cobbles and small boulders, low plastic, dense, moist to very moist and brown to gray in color. The sands and gravels classified as SC to SC-GC soils in accordance with the Unified Soil Classification System.

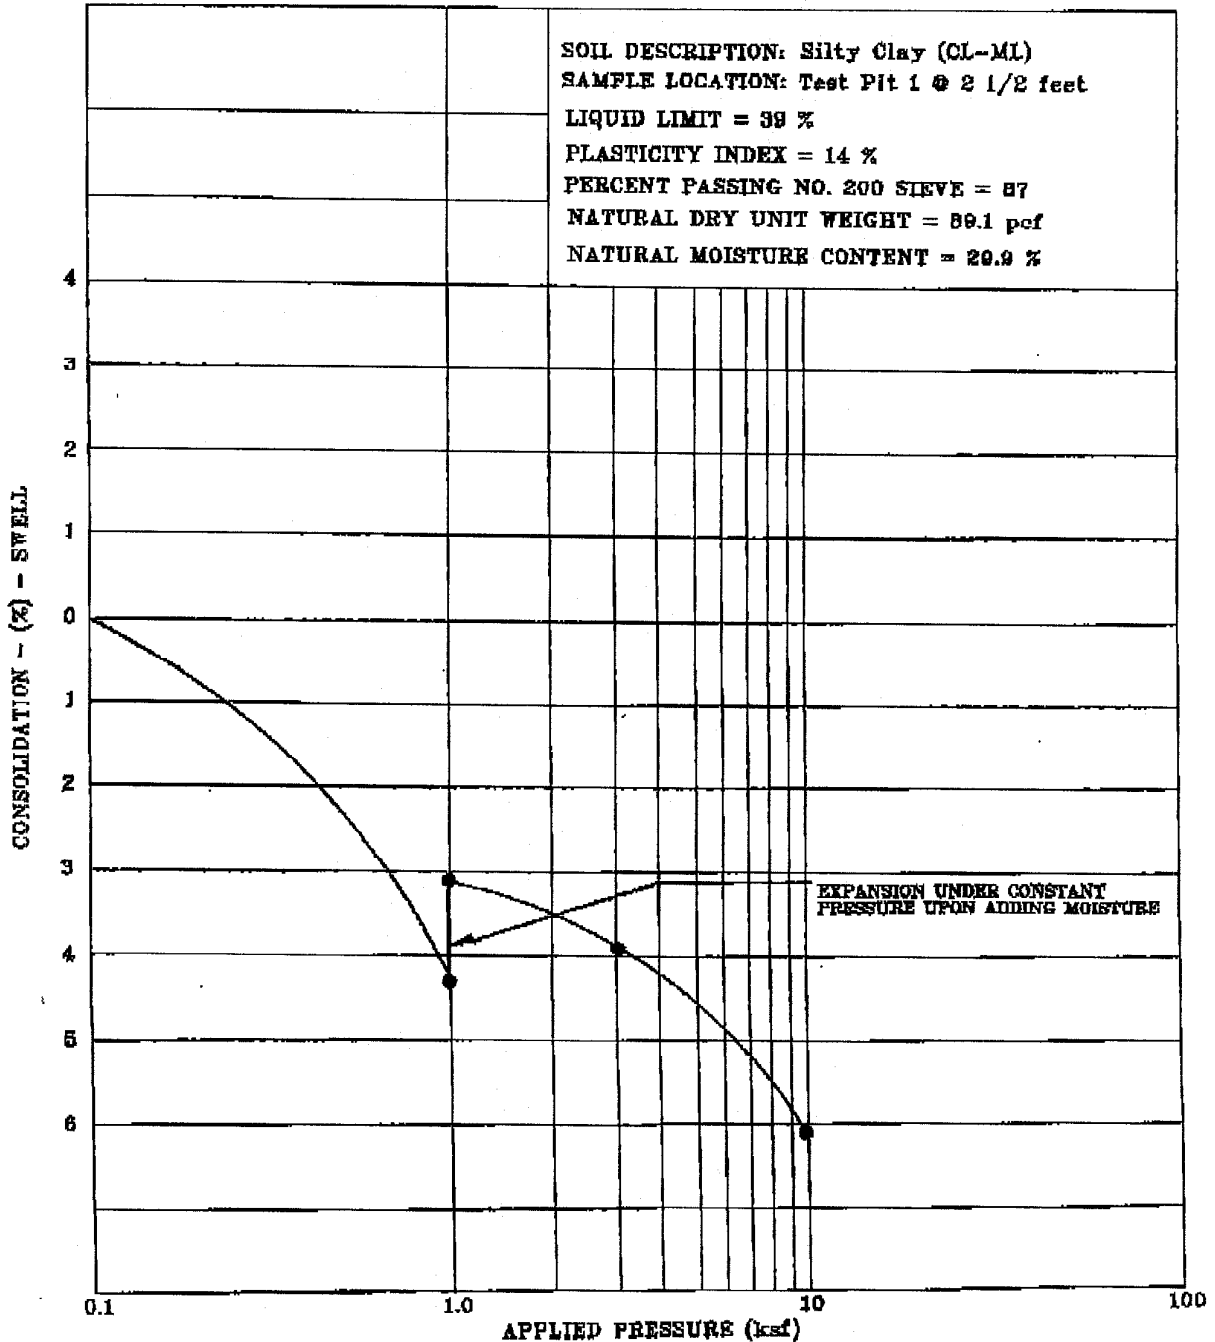
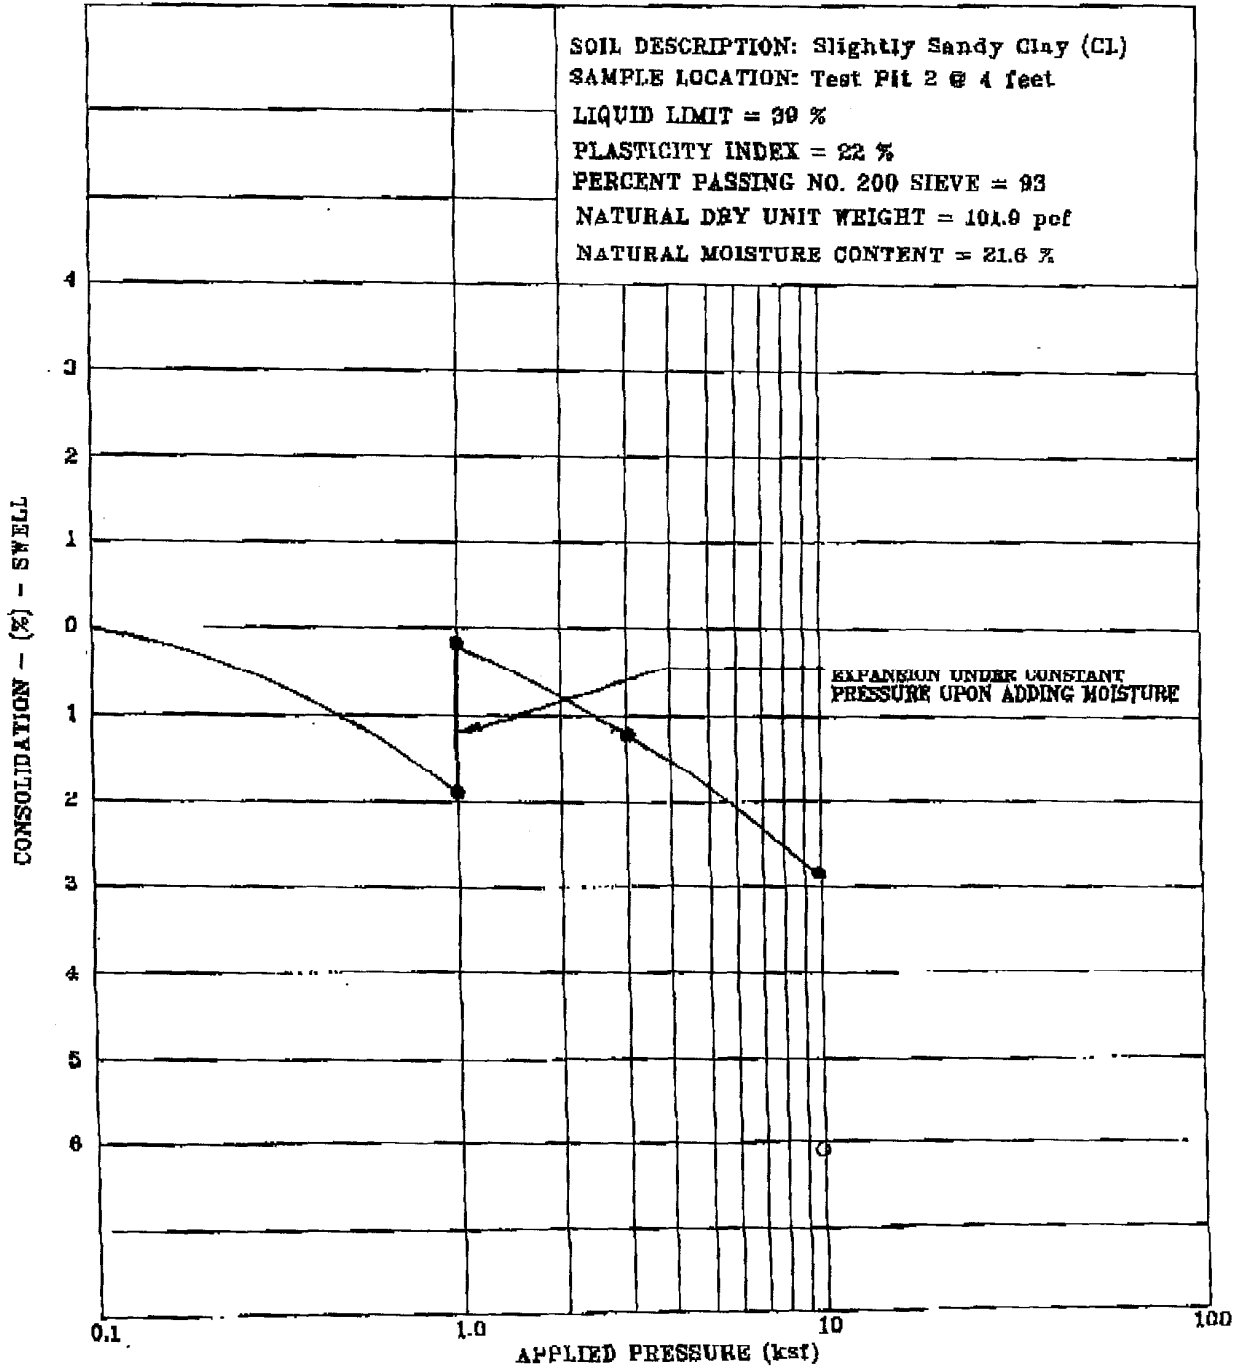
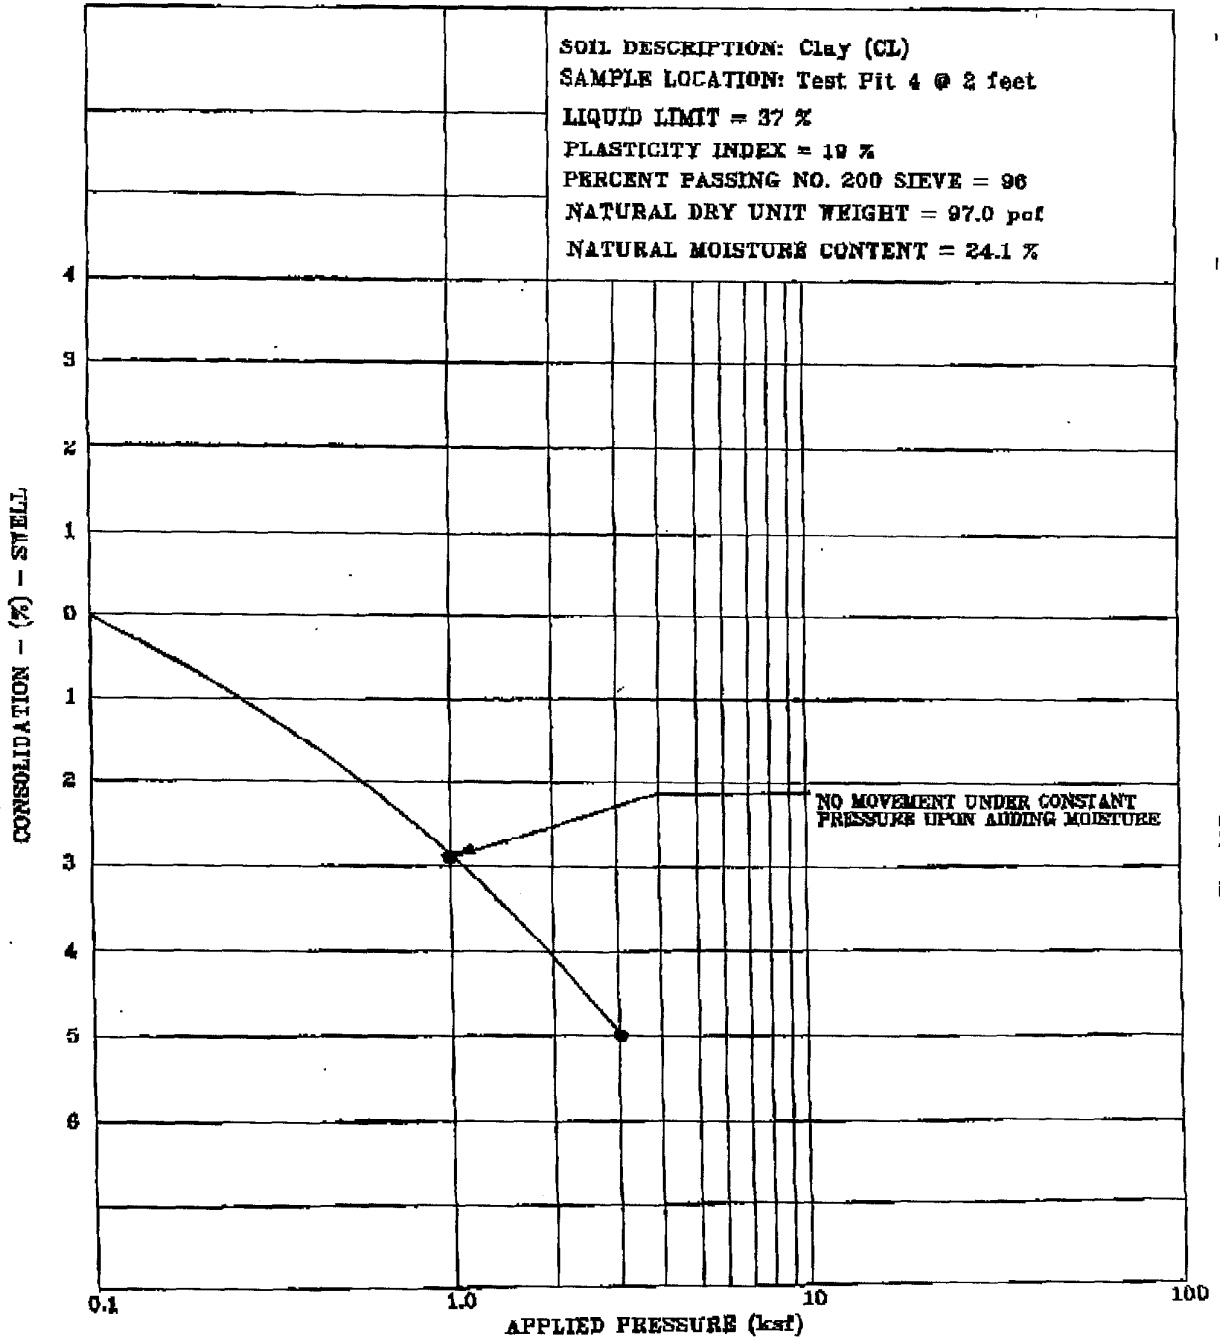
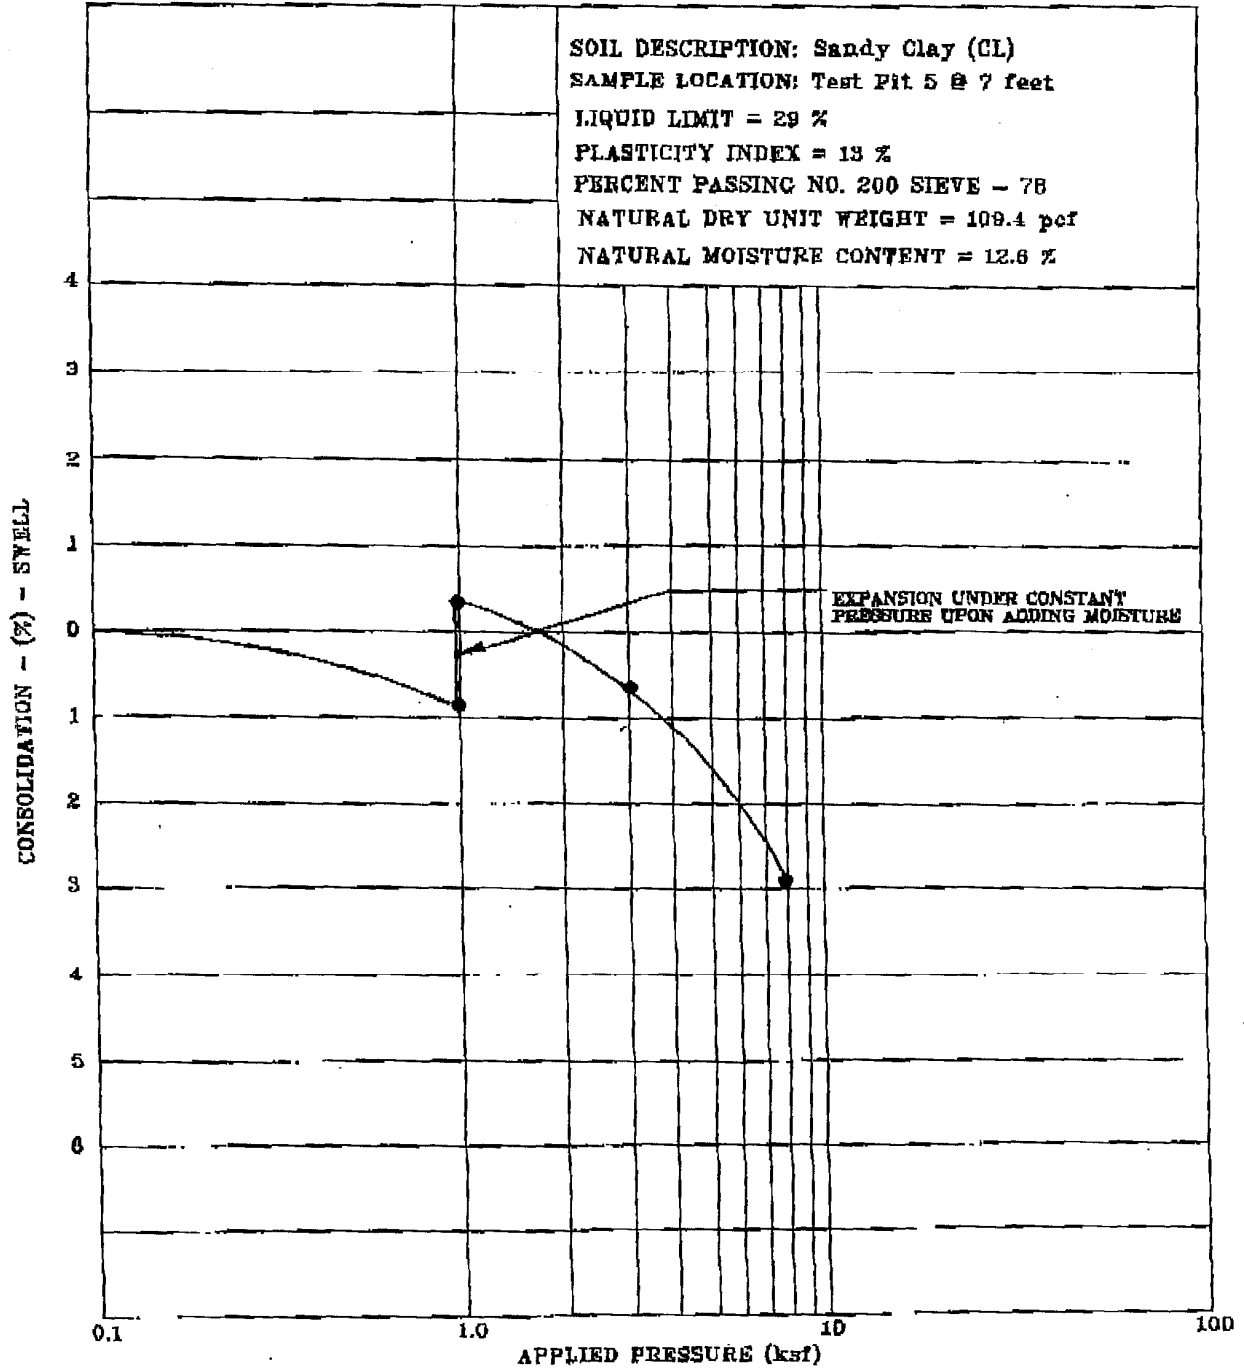
Swell-consolidation testing conducted on relatively undisturbed samples of the natural clay and silt indicate that these materials will exhibit a moderate to high degree of consolidation under relatively light loads and then exhibit a nil to low swell potential when wetted under a constant load. Swell-consolidation testing conducted on samples of the clays indicate that these materials will exhibit a low to moderate degree of consolidation under light loads and then exhibit a low to moderate swell potential when wetted. The swell-consolidation test results are shown in Figures #5 through #8.
